- CD 6 is in need of repair to address sedimentation, vegetation, culvert repairs, and erosion
- Typical ditch repairs occur 8-10 years, CD 6 is beyond average maintenance period
- Repairs to CD 6 should follow the items listed in the repair report to address ditch maintenance, and limit wetland and public water impacts

- JD 1 is in need of repair to address sedimentation, vegetation, culvert repairs, and erosion
- Majority of mainline is below legal grade
- Tree clearing on Branch 2 and areas of mainline
- Branch 1 in need of full repair
- Repairs to JD 1 should follow the items listed in the repair report to address ditch maintenance, limit wetland, public water, and USGWS impacts

- · CD 11 is in need of repair to address sedimentation, vegetation, culvert repairs, and erosion
- Repairs include open ditch cleaning, vegetation removal, side slope flattening, tile outlets, culverts, and buffer seeding
- Typical ditch repairs occur 8-10 years, CD 11 is beyond average maintenance period
- Repairs to CD 11 should follow the items listed in the repair report to address ditch maintenance, limit wetland and public water impacts

- CD 6, JD 1, and CD 11 are in need of repairs to address

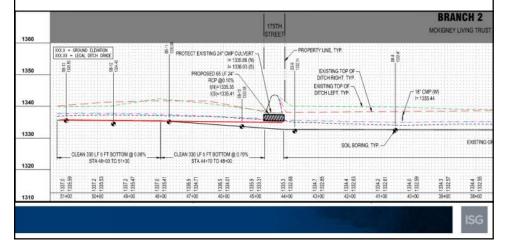
Potential Wetland Impacts

- · CSAH 33-Mainline
- Has major impacts on DNR Public Waters and USFWS
- Culvert is over 2-feet high with upstream areas of JD 1 over excavated
- Lower culvert by 0.2 feet for flat drainage from 490th Ave (0.02 acres of wetland impacts

Lower culvert by 0.5 for positive drainage (0.22 acres of wetland impacts*)

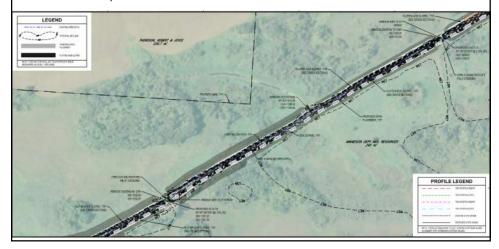
Public Waters Impacts

- · Repairs in Public Waters will be avoided
- No repairs to outlet structures or berm structures
- No fill placed in Public Waters or wetlands

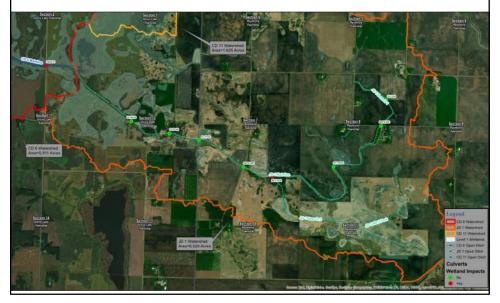
Potential Wetland Impacts

- CSAH 33-Mainline
- Has major impacts on DNR Public Waters and USFWS
- Culvert is over 2-feet high with upstream areas of JD 1 over excavated
- Lower culvert by 0.2 feet for flat drainage from 490th Ave (0.02 acres of wetland impacts
- Lower culvert by 0.5 for positive drainage (0.22 acres of wetland impacts*)

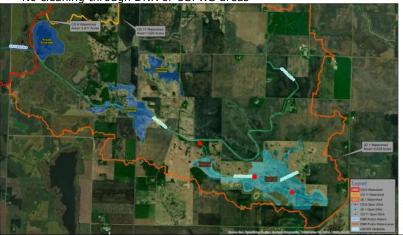
Public Waters/USFWS Impacts

- · Repairs in Public Waters will be avoided
- No repairs to outlet structures, weirs, or berm structures
- No fill placed in Public Waters or wetlands
- No cleaning through DNR or USFWS areas
