- CD 6 is in need of repair to address sedimentation, vegetation, culvert repairs, and erosion
- Typical ditch repairs occur 8-10 years, CD 6 is beyond average maintenance period
- Repairs to CD 6 should follow the items listed in the repair report to address ditch maintenance, and limit wetland and public water impacts

- JD 1 is in need of repair to address sedimentation, vegetation, culvert repairs, and erosion
- Majority of mainline is below legal grade
- Tree clearing on Branch 2 and areas of mainline
- Branch 1 in need of full repair
- Repairs to JD 1 should follow the items listed in the repair report to address ditch maintenance, limit wetland, public water, and USGWS impacts

- · CD 11 is in need of repair to address sedimentation, vegetation, culvert repairs, and erosion
- Repairs include open ditch cleaning, vegetation removal, side slope flattening, tile outlets, culverts, and buffer seeding
- Typical ditch repairs occur 8-10 years, CD 11 is beyond average maintenance period
- Repairs to CD 11 should follow the items listed in the repair report to address ditch maintenance, limit wetland and public water impacts

- CD 6, JD 1, and CD 11 are in need of repairs to address

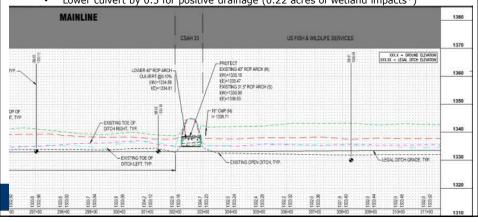
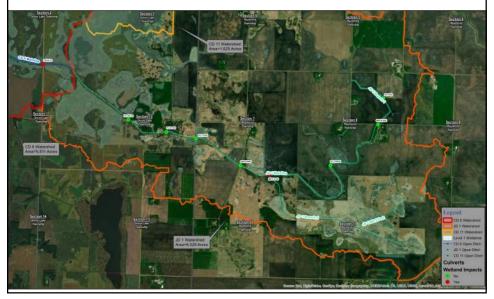
Potential Wetland Impacts

- · CSAH 33-Mainline
- Has major impacts on DNR Public Waters and USFWS
- Culvert is over 2-feet high with upstream areas of JD 1 over excavated
- Lower culvert by 0.2 feet for flat drainage from 490th Ave (0.02 acres of wetland impacts

Lower culvert by 0.5 for positive drainage (0.22 acres of wetland impacts*)

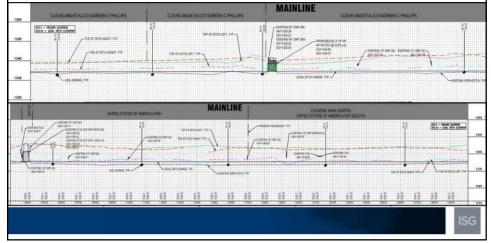
Legal Grade Determination

- Utilized topographic survey, original design profile, soil boring elevations, correspondence documents, to develop profile plot
- Majority of mainline and Branch 2 determined to be over excavated

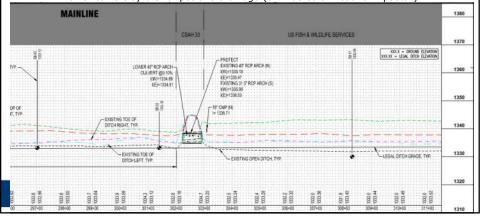
- CSAH 33-Mainline
- Has major impacts on DNR Public Waters and USFWS
- Culvert is over 2-feet high with upstream areas of JD 1 over excavated
- Lower culvert by 0.2 feet for flat drainage from 490th Ave (0.02 acres of wetland impacts
- Lower culvert by 0.5 for positive drainage (0.22 acres of wetland impacts*)
