## Sauk River Watershed Drainage Authority 103E Ditch Inspection Report CY 2019

As the Sauk River Watershed Drainage Authority (SRWDA) Ditch Inspector, it is my duty to report that the condition of the 12 public drainage systems under your authority range from poor to good condition.

The SRWDA is the drainage authority for two county drainage systems in Pope County, eight county drainage systems in Stearns County and one joint drainage system between Pope and Stearns Counties.

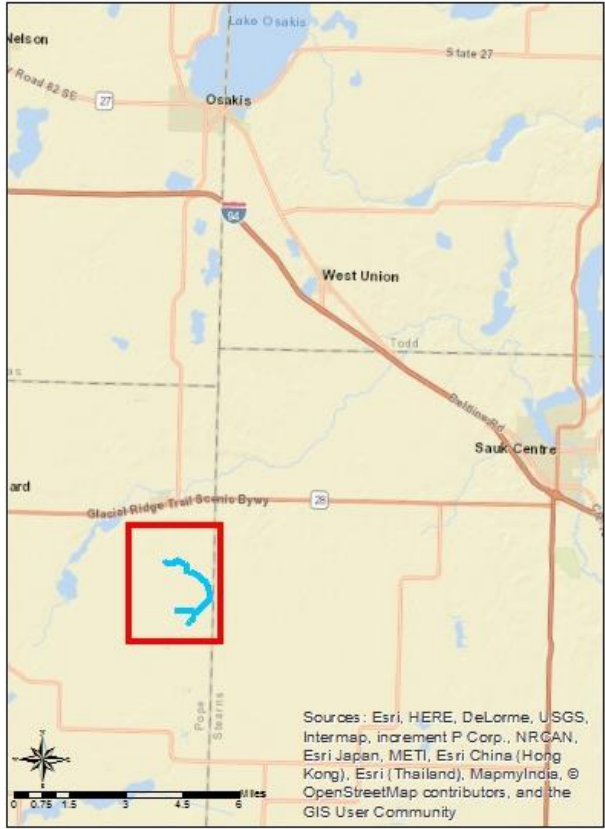
**Pope County Ditch 11**

The land area drained by Pope County Ditch 11 lies 7.5 South East of Westport, Minnesota. The Ditch consists of the Main Stem outleting into Branch One of County Ditch 6 and a lateral outleting into Kranz Lake. The total ditch length is 3.5 miles.

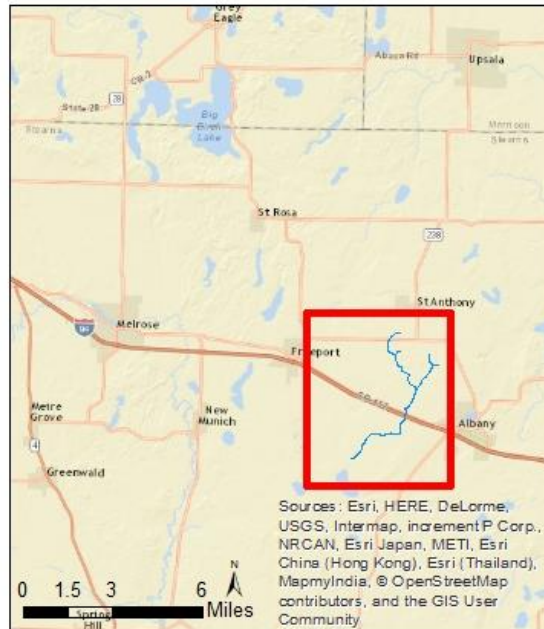
CD15 Benefited Area

County Ditch 15 consists of a main stem and two branches. The ditch flows from north to south terminating approximately 3,300 feet east of County Ditch 26. The main stem of the ditch is just over 5 miles, branch 1 is just under half a mile, and branch two is a little over 3 miles.
